## *Flood Control and Riparian Restoration*

# Meeting Environmental and Drainage Requirements for Multi-objective Channels

## WETLAND NOTES

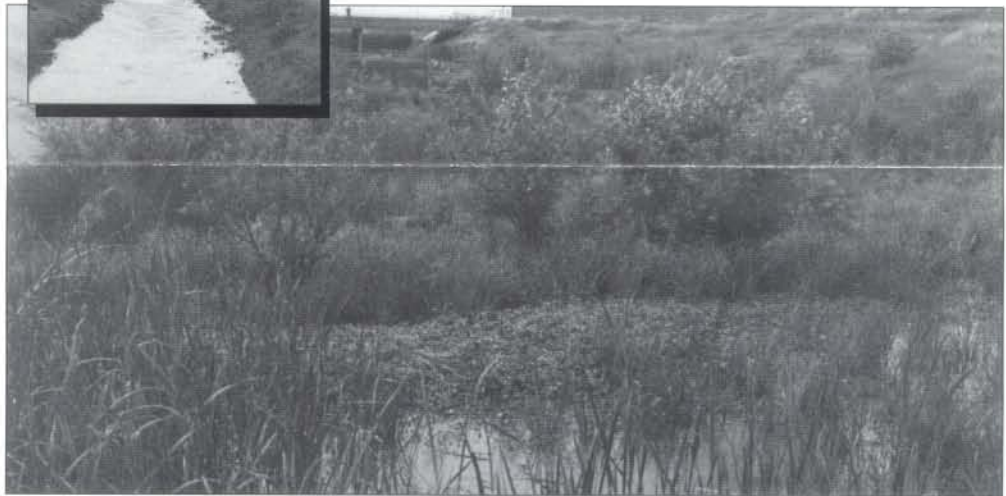
*Figure 1. Typical trapezoidal channel in photo (left) became a larger and often less efficient channel (below) to meet environmental concerns.*

California has had extensive and significant flooding over the past two centuries. In the mid-18th century, the new capital in Sacramento was 11 feet under water after a particularly serious deluge. During the heyday of development in California after World War II, flood control needs were met by excavating waterways (which had often already been channelized by farmers) into relatively narrow, trapezoidal channels (inset, Figure 1).

In Sacramento, for example, the Strawberry Creek channel (downstream reach) was constructed in 1985 as an expanded trapezoidal channel. Although sediment loads in this system are relatively low, the channel bottom rapidly developed a forest of willows (Figure 1). The

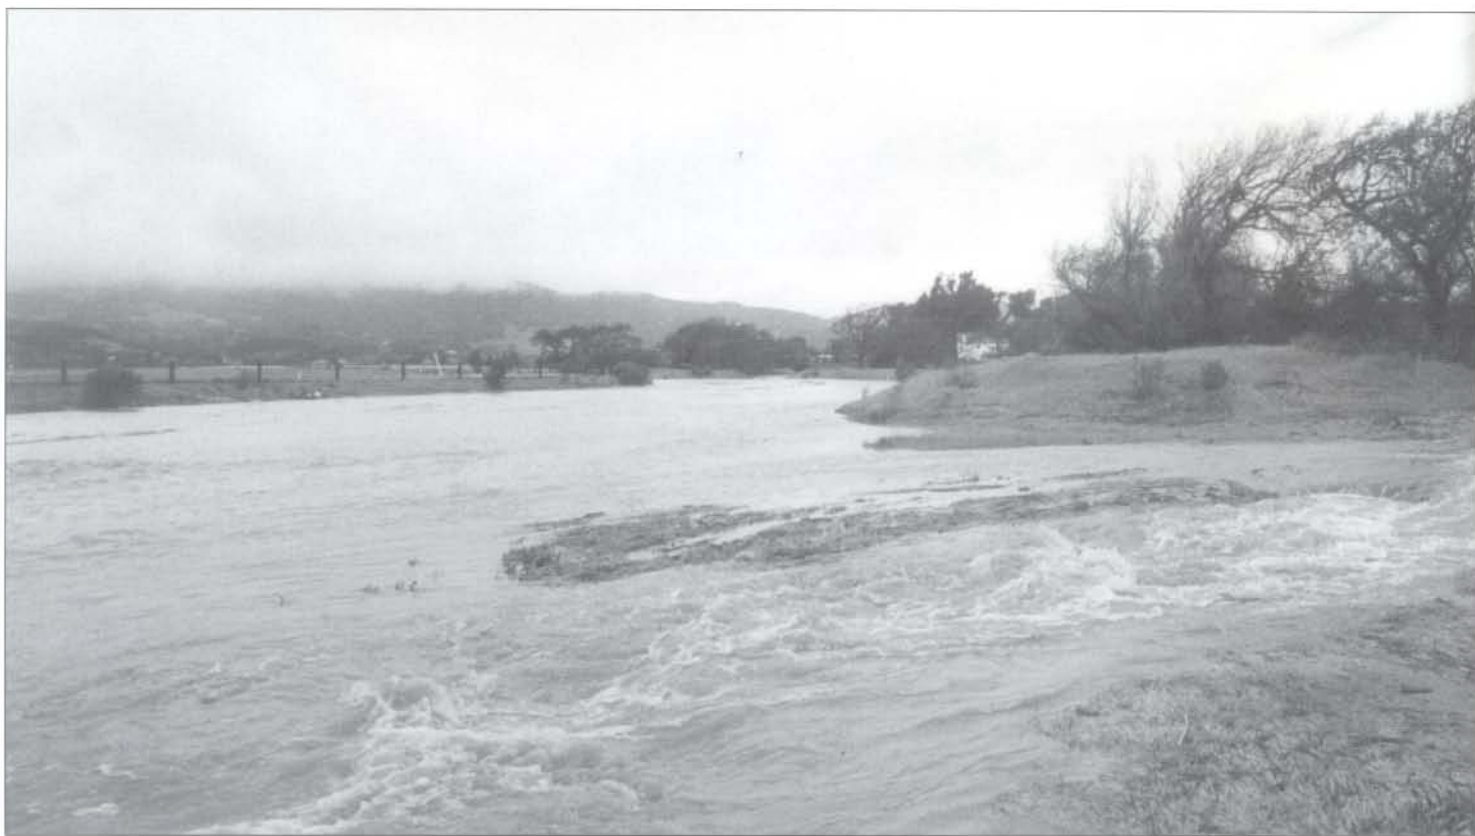
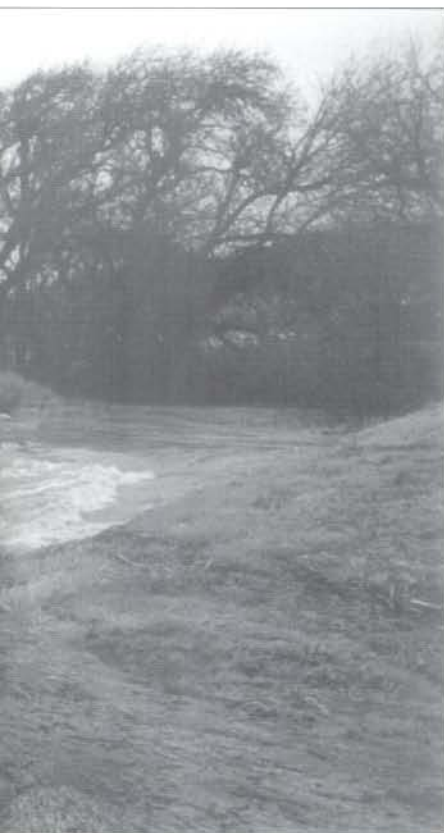
*Figure 2: Green Valley Creek in Fairfield is a good example of a compound channel design.*

*During significant storms the water level of the natural creek channel (seen at the right in this photo) will rise and flow through wide cuts in the bank. It then spreads out across the broad overflow terrace where velocity is greatly diminished.*

The compound channel designed adopted by the City includes an overflow terrace parallel to the natural channel sufficient to hold significant storms (Figure 2). The overflow terrace is at the mean annual storm level, about 3 feet above the invert of the natural channel. This ensures that, once waters reach flood stage, they can siphon off to a broad floodplain where velocities slow considerably. Sedimentation is slight to nonexistent in the overflow terrace because most of the sediment is gravel and sand; the natural channel has enough capacity to retain this material. Growth of low terrace riparian species, such

as willows, that can greatly reduce capacity are almost nonexistent in the overflow terrace because the terrace is high enough to ensure that any seedlings that do reach the terrace do not receive enough summer moisture to survive. As importantly, the overflow terrace provides a highly suitable environment for the development of seasonal marshes and wet meadows, two types of wetlands requiring restoration under the wetland permits.

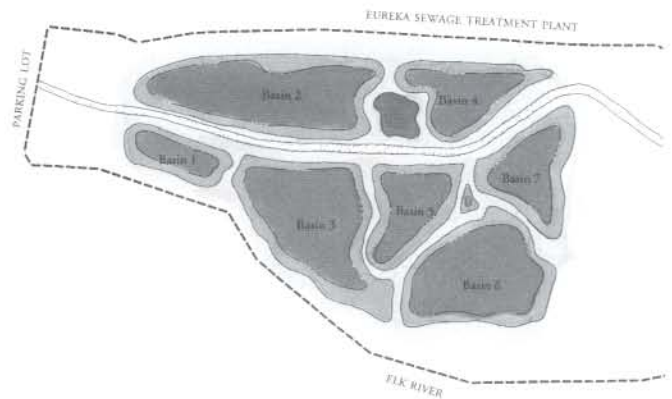
The south Broadway site is comprised of eight seasonal marsh basins with associated woodland fringe.

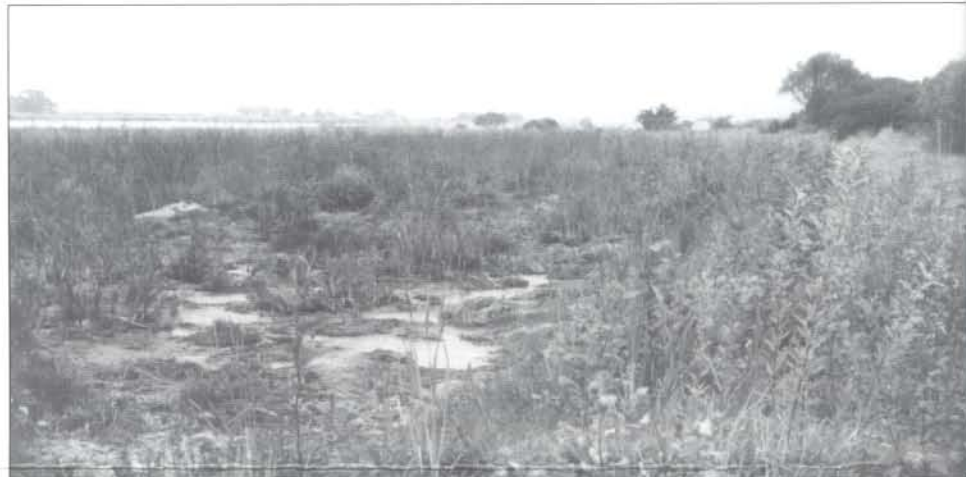
Top photo: Looking north at Basin 2 in August, 1993.

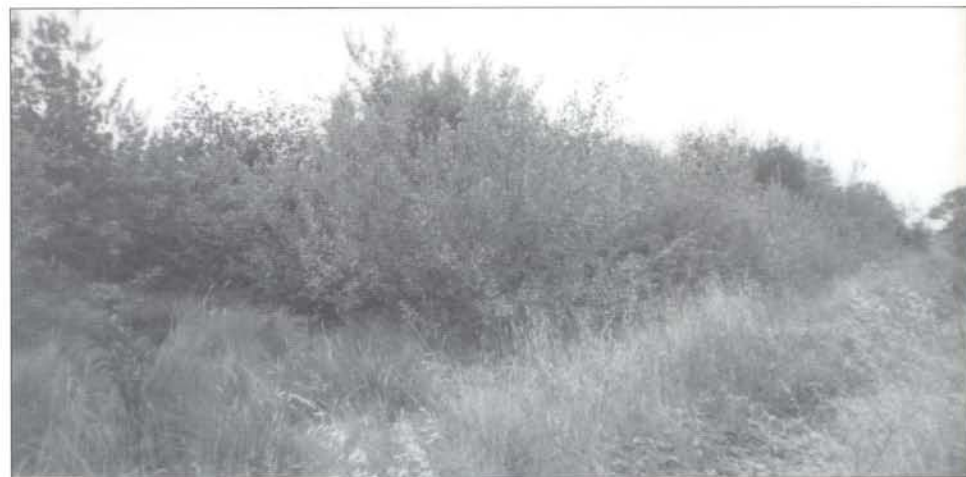
Bottom photo: Same location as above in July 1997 clearly shows the riparian fringe that has developed around each of the basins.

The most striking visual change after five years is the development of dense riparian fringes dominated by alder (*Alnus rubra*) and arroyo willow (*Salix lasiolepis*) around the basins, which until about 1996 were quite open. These riparian edges provide good cover for wildlife and make the project almost indistinguishable from the reference sites.

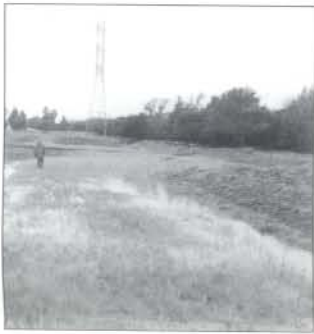
### Red Top Road - Fairfield

*At Red Top Road the plans call for construction of a park and ride lot and other facilities. Mitigation included construction of 2 small and 1 large wetland basin with connections to the adjacent creek. The basins involved some very subtle grading concepts that were difficult to understand on the engineering drawings. We were actually building 2 basins in 1 in all cases. When clarification was warranted our onsite ecological monitor offered guidance that lead to the project moving ahead smoothly. We also worked closely with the landscape contractor to make the best of what was a poor growing season for their suppliers. The project is off to a great start.*

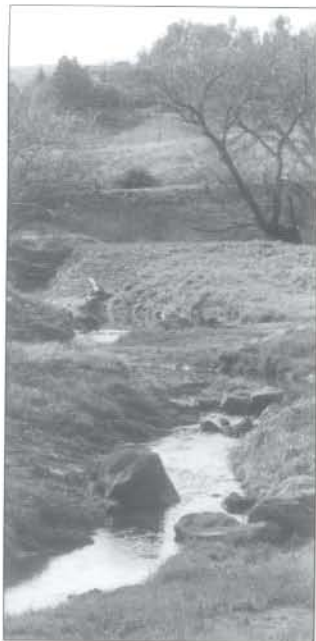
### Detention Basin 57 - Martinez

*The basin design included relocation and extension of a short reach of existing creek and construction of a broad terrace to collect excess runoff and meter it out through 2 new drainage structures. As construction began our EM recognized that a minor adjustment to the planned creek alignment could lead to improved wildlife habitat and possibly expanded flood capacity. After agency review and approval, the shift was made as grading got underway.*

*Weeks later, construction at the nearby home sites began to be slowed by large volumes of bedrock uncovered during rough grading. A plan was presented by the EM which lead to a large number of boulders being incorporated into the new creek channel. These are already beginning to look like they have been there for years. In the spring, these rocks will provide added cover for fish and other wildlife. Offsite rock disposal costs have been sharply reduced as a result of this plan.*
